SANTA FE WATERSHED PAIRED BASIN STUDY

THE FIRST SIX YEARS

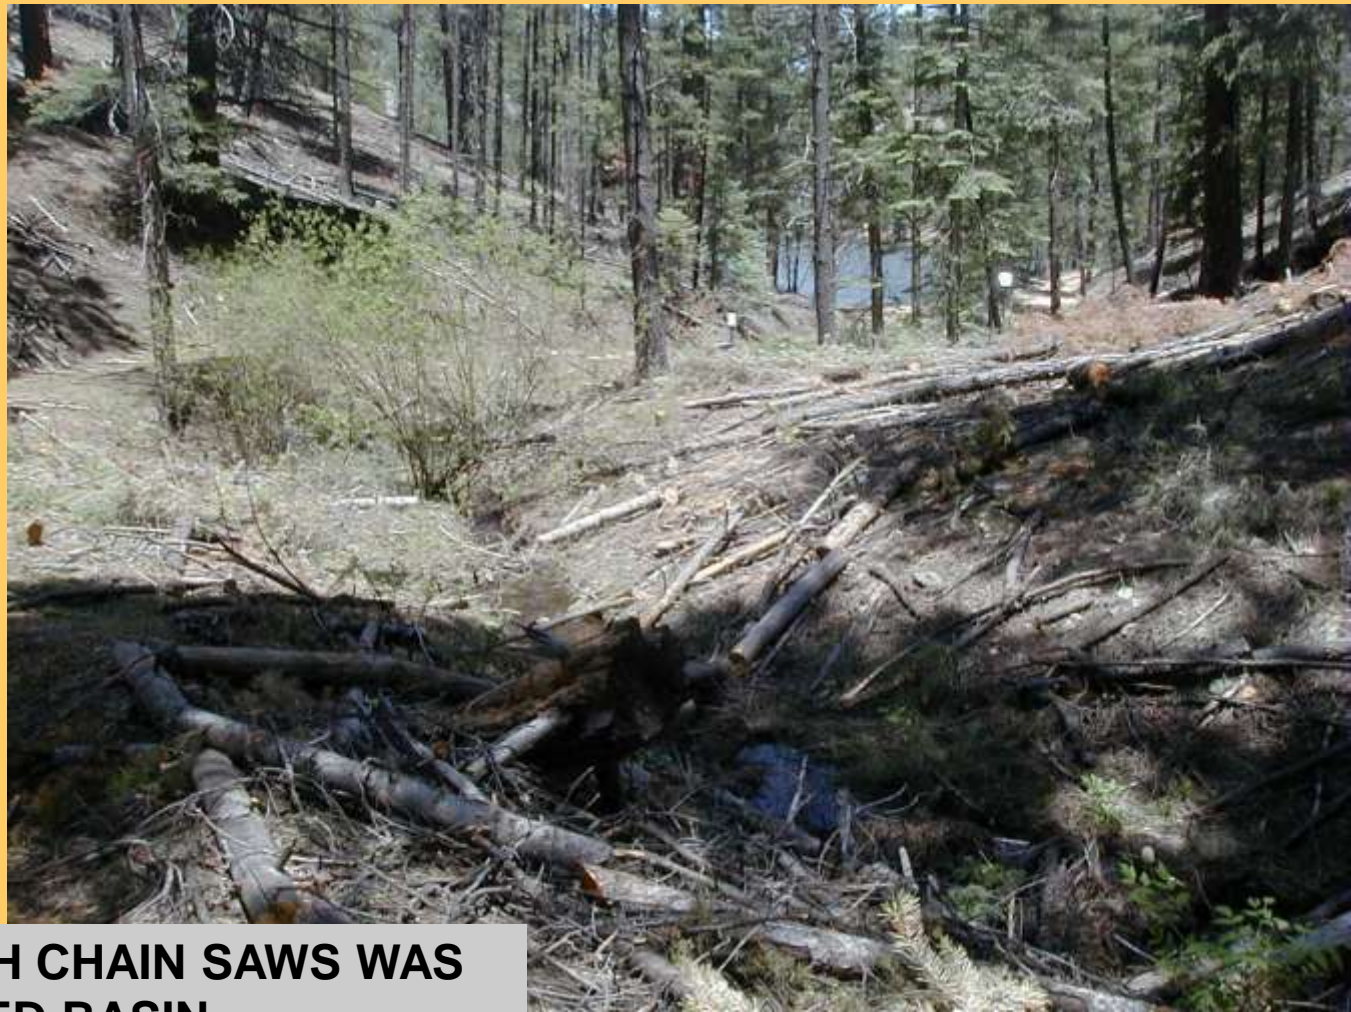
**HAND THINNING WITH CHAIN SAWS WAS
DONE IN THE TREATED BASIN.**

SHOWN HERE BEFORE BURNING.

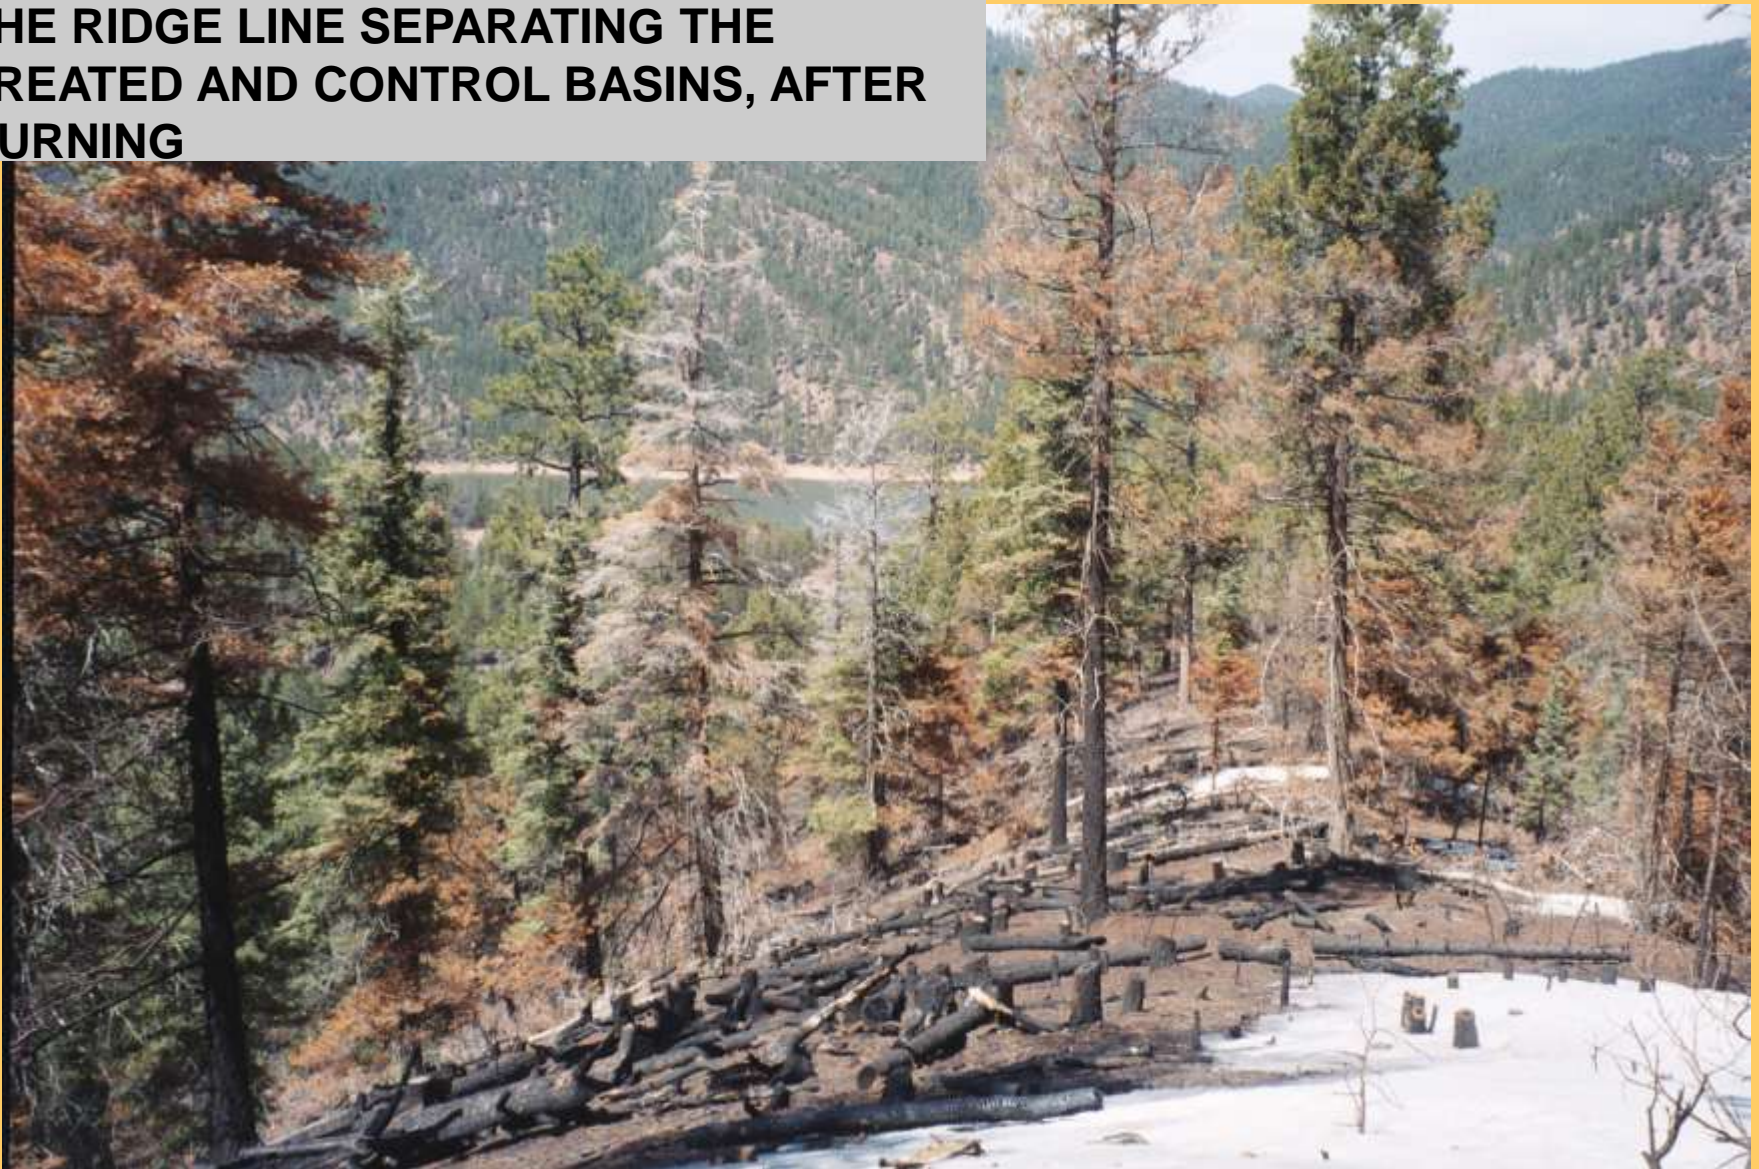
THE RIDGE LINE SEPARATING THE TREATED AND CONTROL BASINS, AFTER BURNING

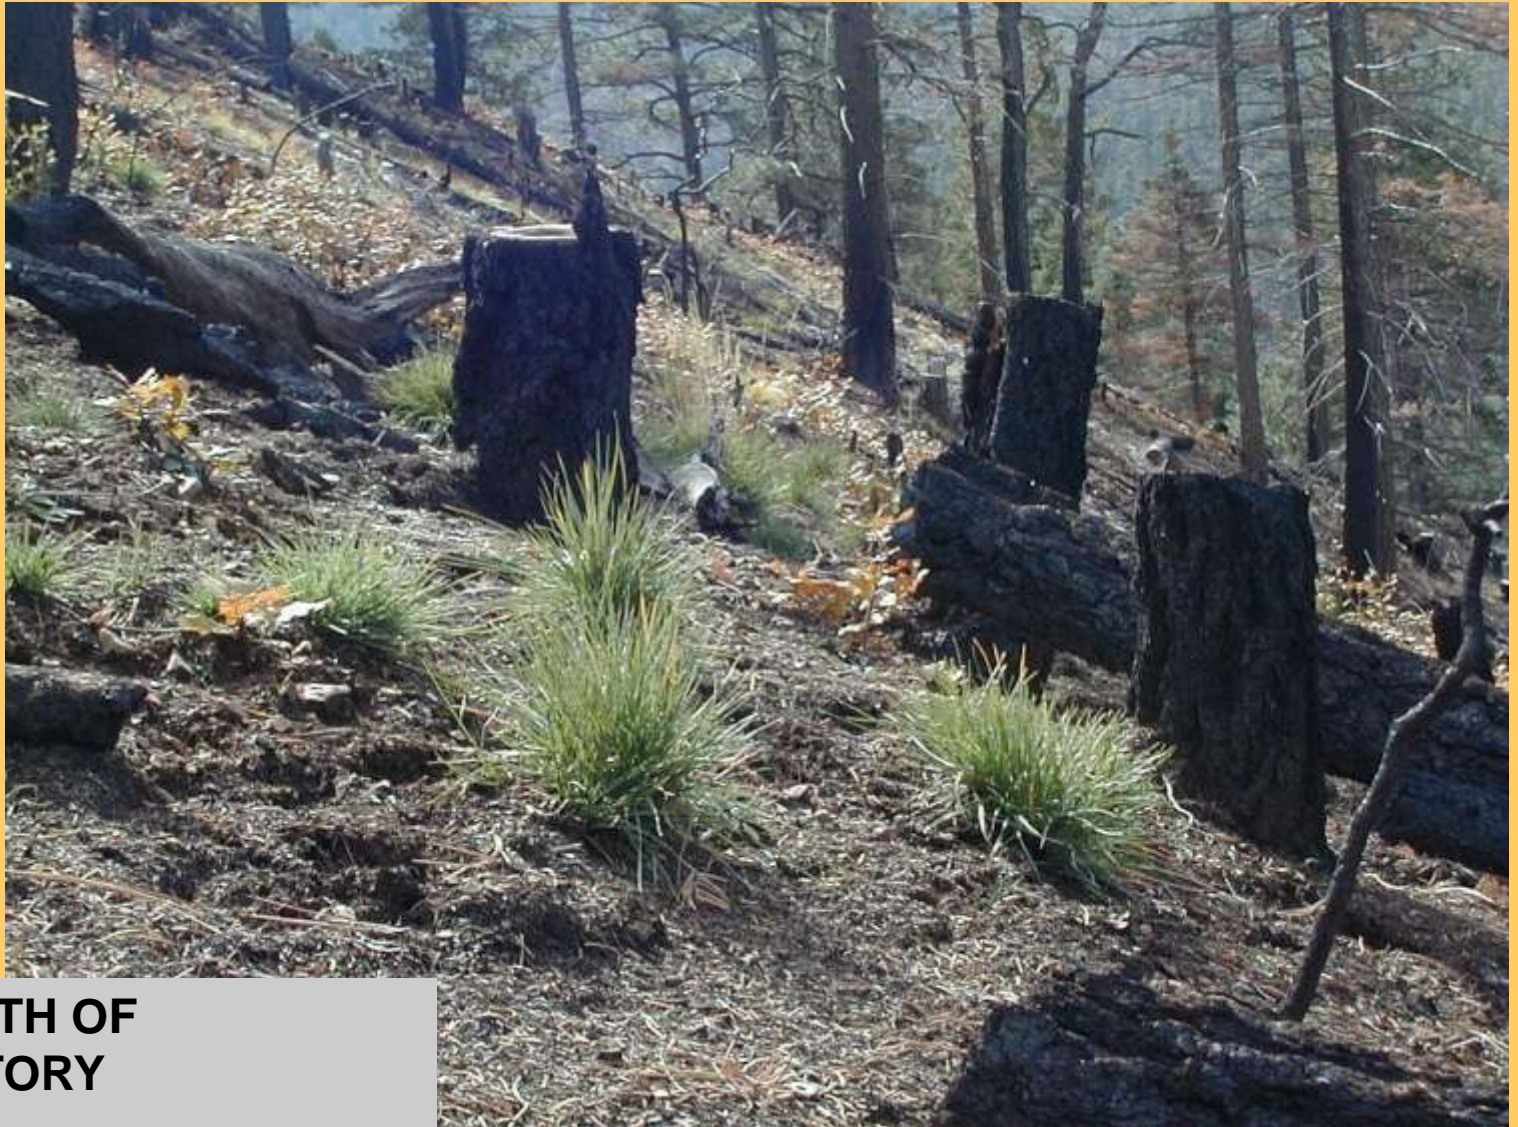
**REGROWTH OF
UNDERSTORY
ONE YEAR AFTER**

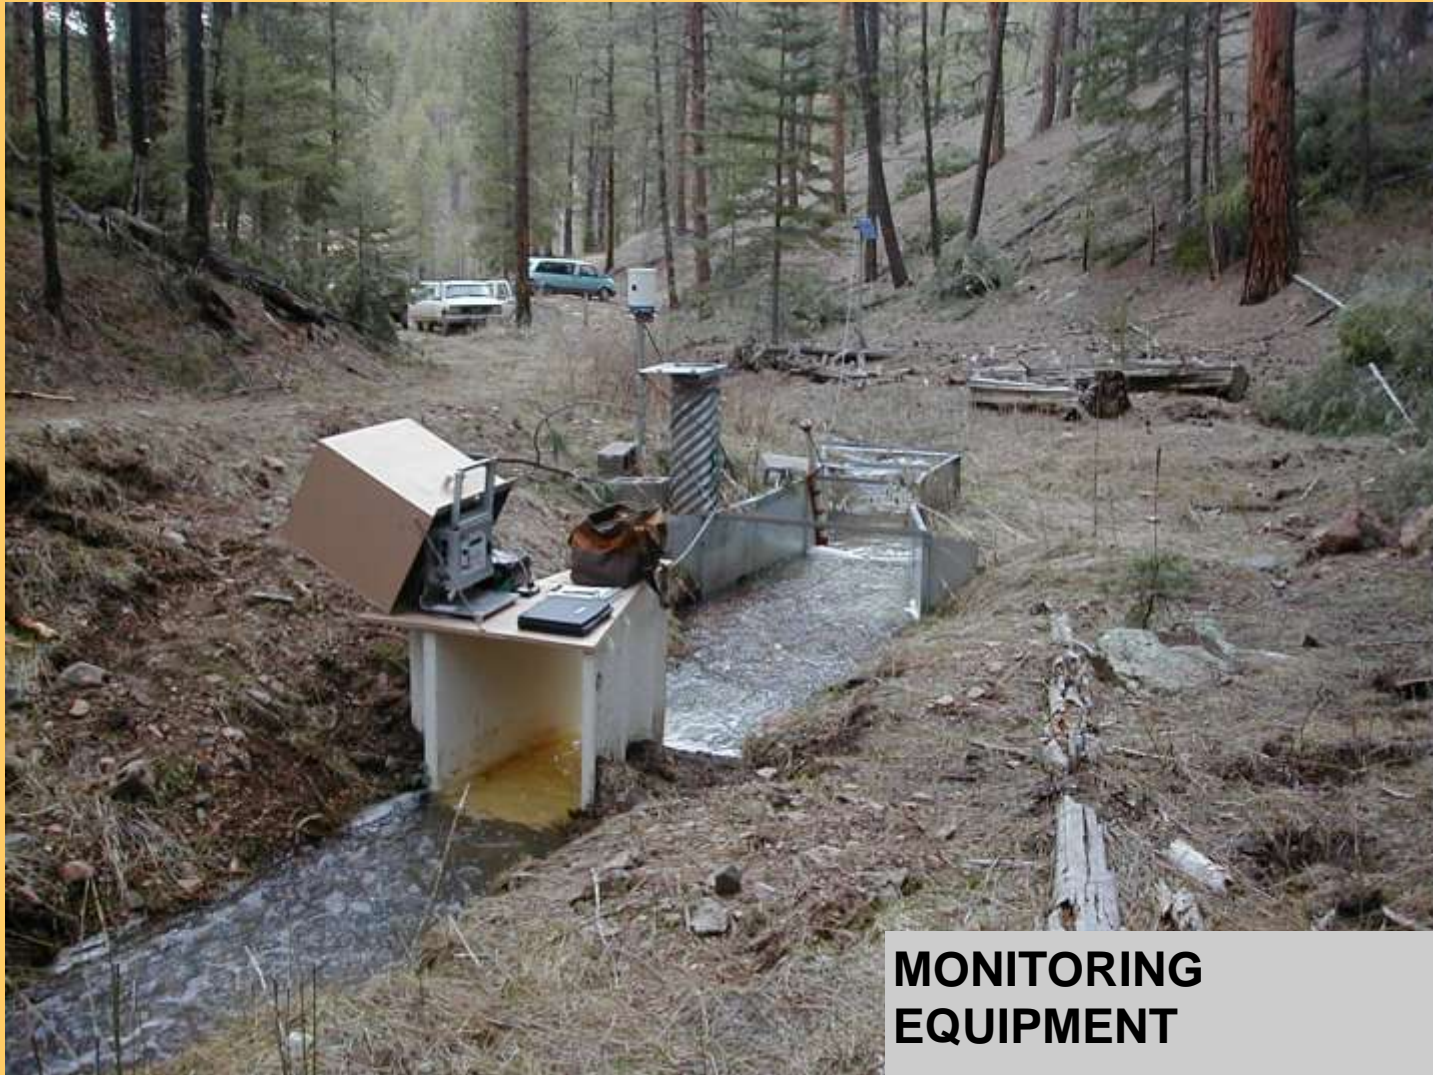
**MONITORING
EQUIPMENT**

TREATED BASIN

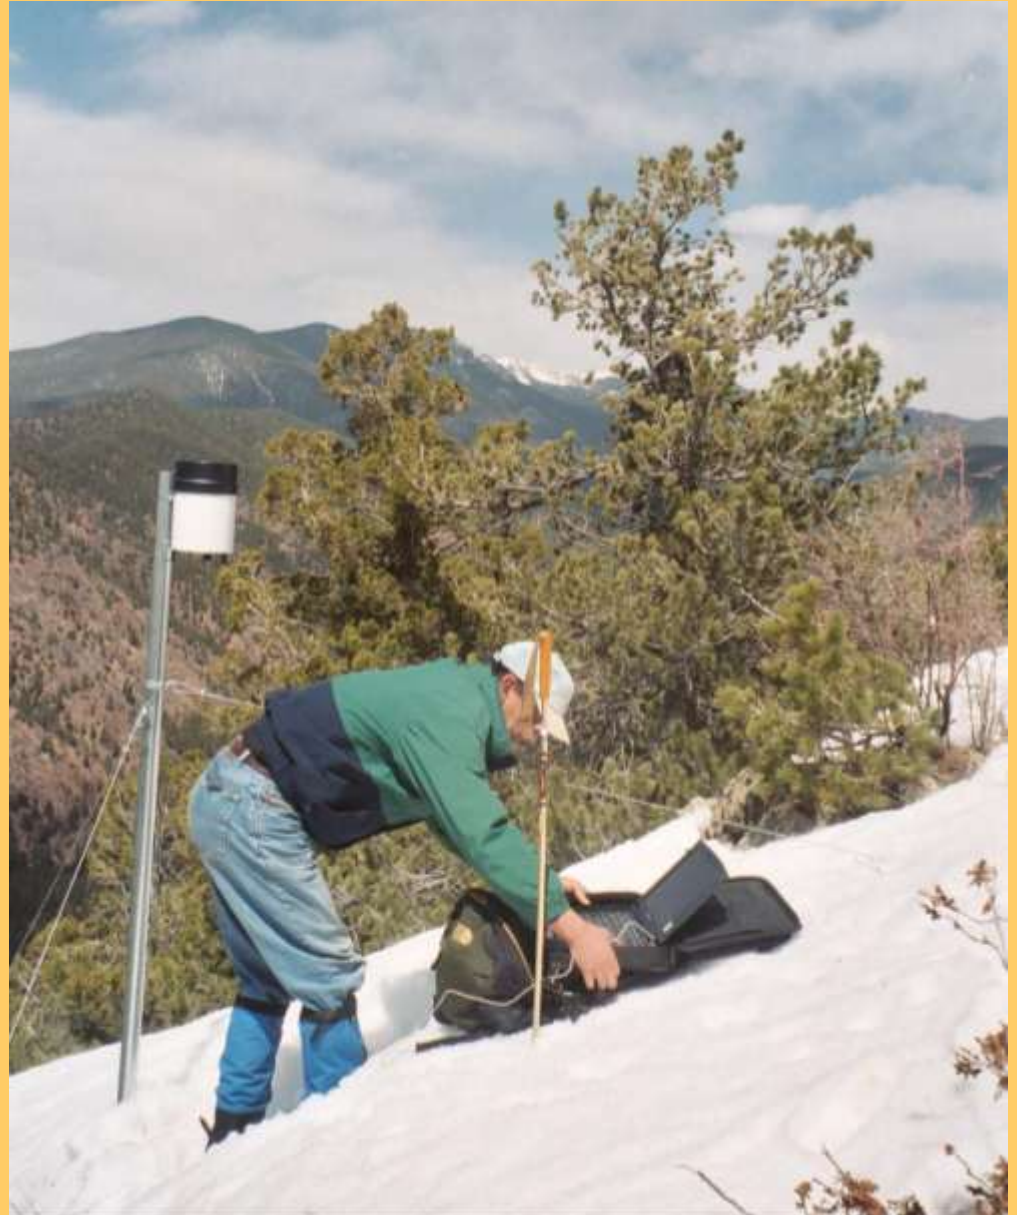
**COLLECTING DATA AT THE
MID ELEVATION RAIN GAGE**

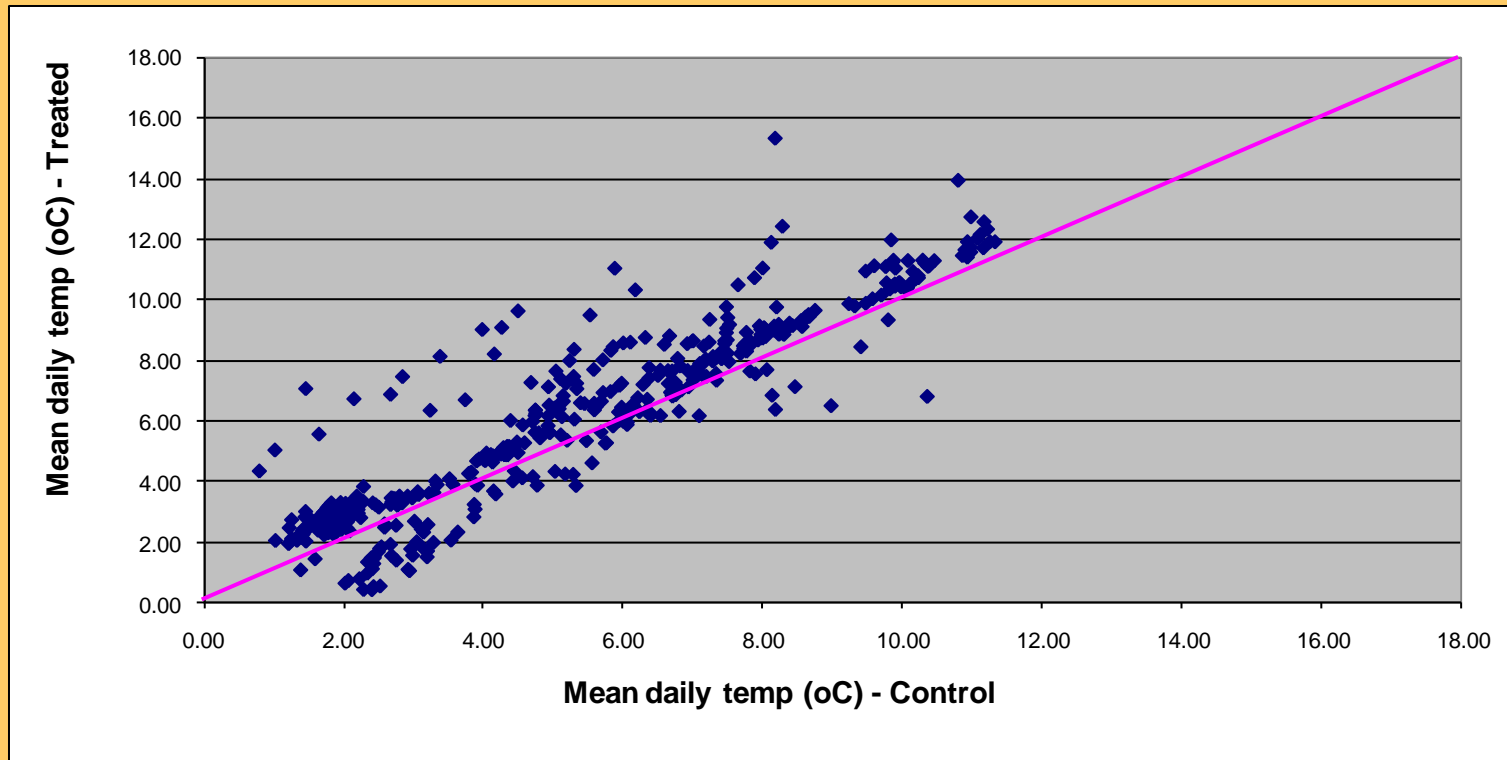
TREATED BASIN WATER WAS WARMER THAN CONTROL

BOTH BASINS WERE WARMER POST-THINNING THAN DURING PRE-THINNING PERIOD

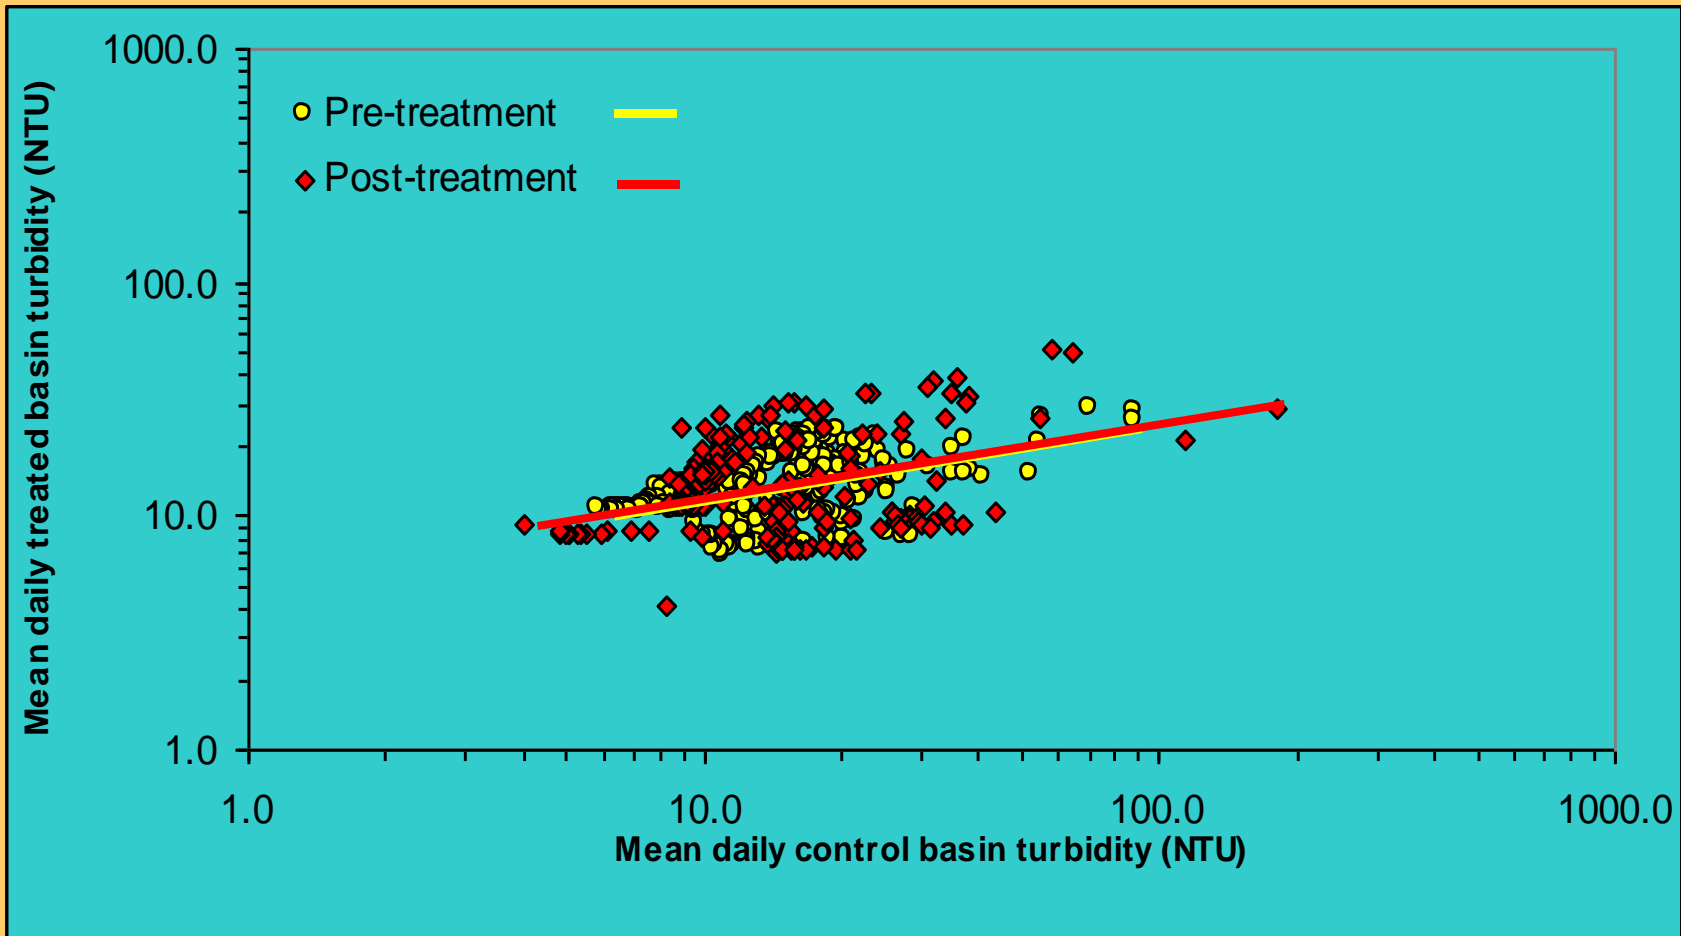
**NO STATISTICAL DIFFERENCE
IN TURBIDITY DUE TO
TREATMENT**

Variable	Pre-treatment	Post-treatment
Ctl Trb	12.4	12.7
Trt Trb	13.4	13.5

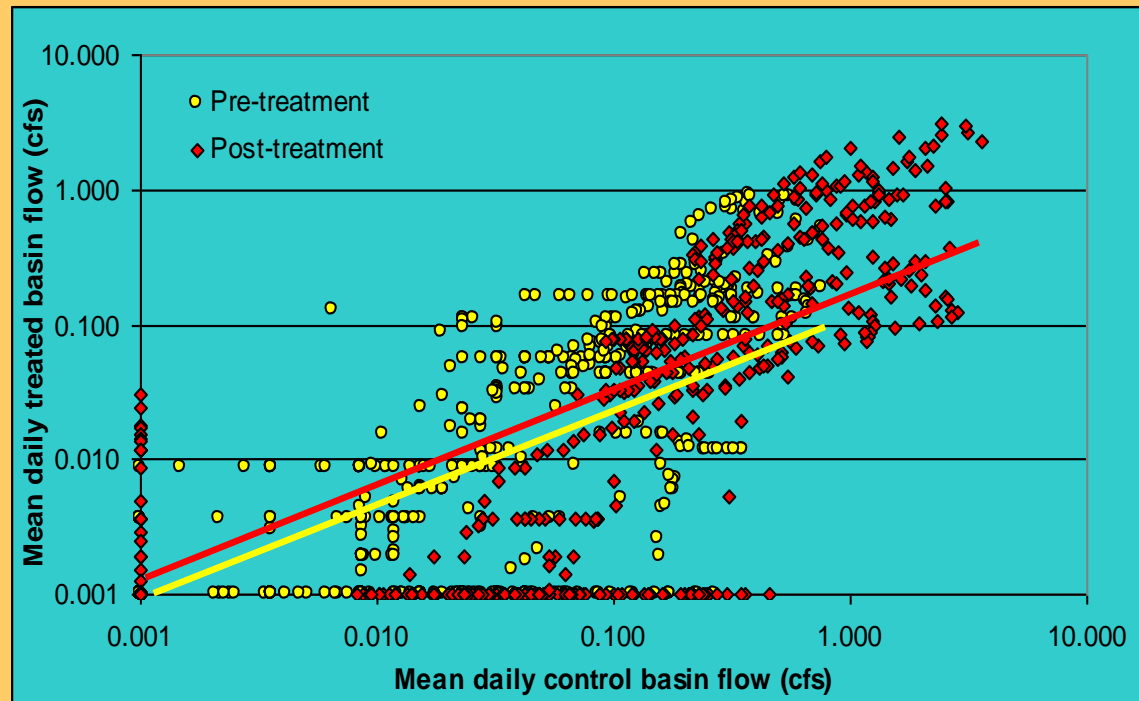
REGRESSION MODELING INDICATES:

MEAN DAILY FLOW FROM TREATED BASIN GREATER AFTER TREATMENT

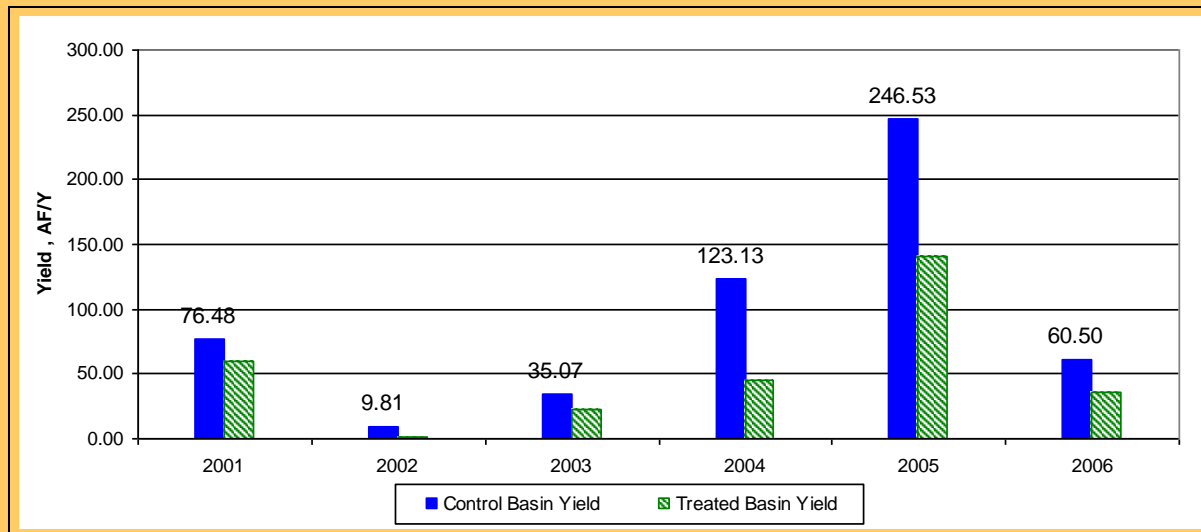
TOTAL YIELD VARIED SIGNIFICANTLY FROM YEAR TO YEAR
