## SLIDE FIRE BAER SEVERITY ASSESSMENT

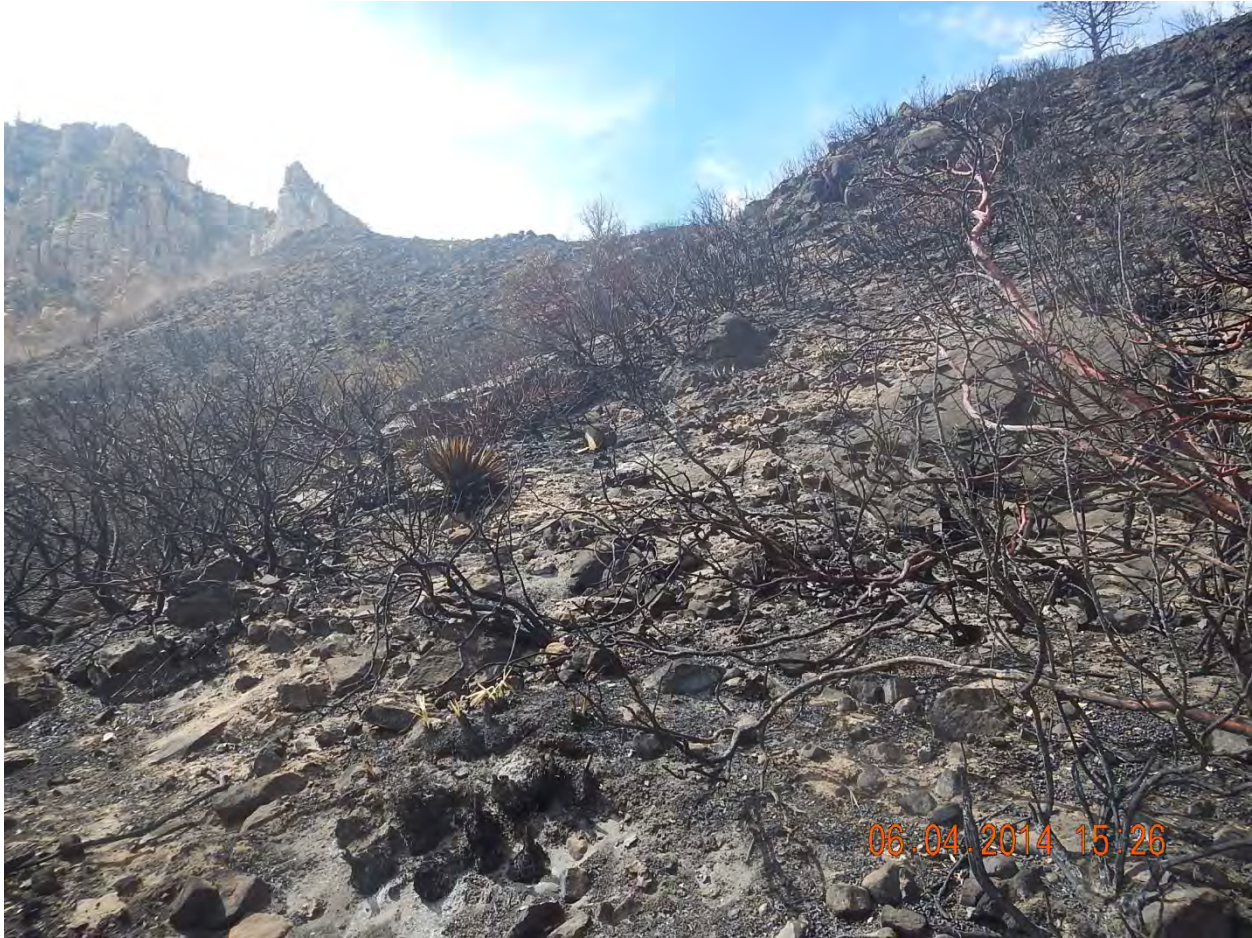
6/4/2014 - The Slide Fire removed vegetation in many areas, including steep canyons. Rock fall has always been a risk in these areas. Roots, from trees and shrubs burned in the fire, no longer holding rocks, subject the canyons to increased potential for dry ravel and rock fall. This progressive accumulation of sediment without vegetation to slow it down creates an increased impact throughout Oak Creek Canyon.

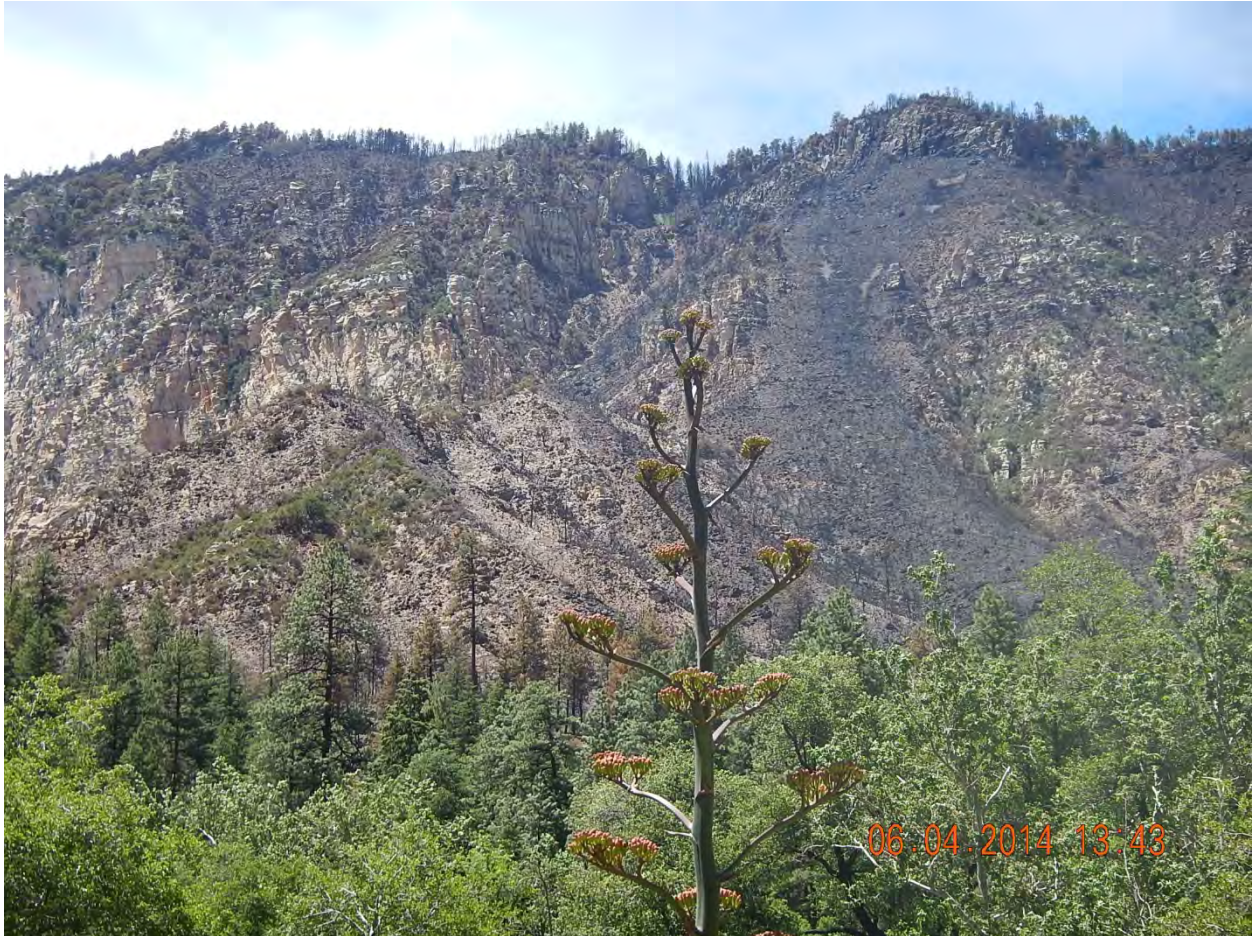
6/4/2014 - The Slide Fire removed vegetation in many areas, including steep canyons. Rock fall has always been a risk in these areas. Roots, from trees and shrubs burned in the fire, no longer holding rocks, subject the canyons to increased potential for dry ravel and rock fall. This progressive accumulation of sediment without vegetation to slow it down creates an increased impact throughout Oak Creek Canyon. A BAER team crew heard rock fall already occurring during one field assessment day this week.

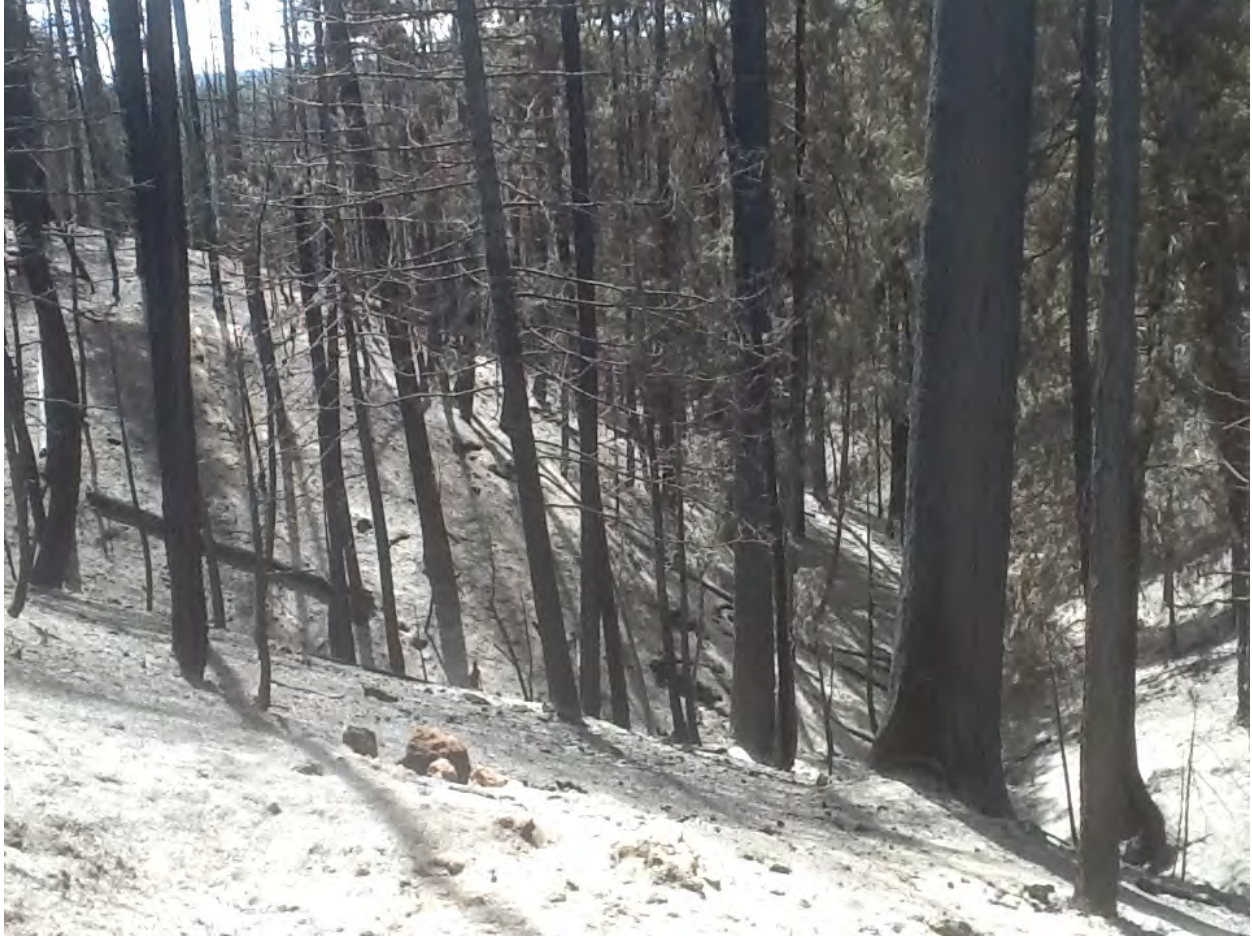
6/4/2014 – A thick layer of powdery gray or white ash covering the ground is an indicator of high soil burn severity. Ash and debris can be swept into rivers and streams by summer rain storms, potentially impacting downstream water sources.

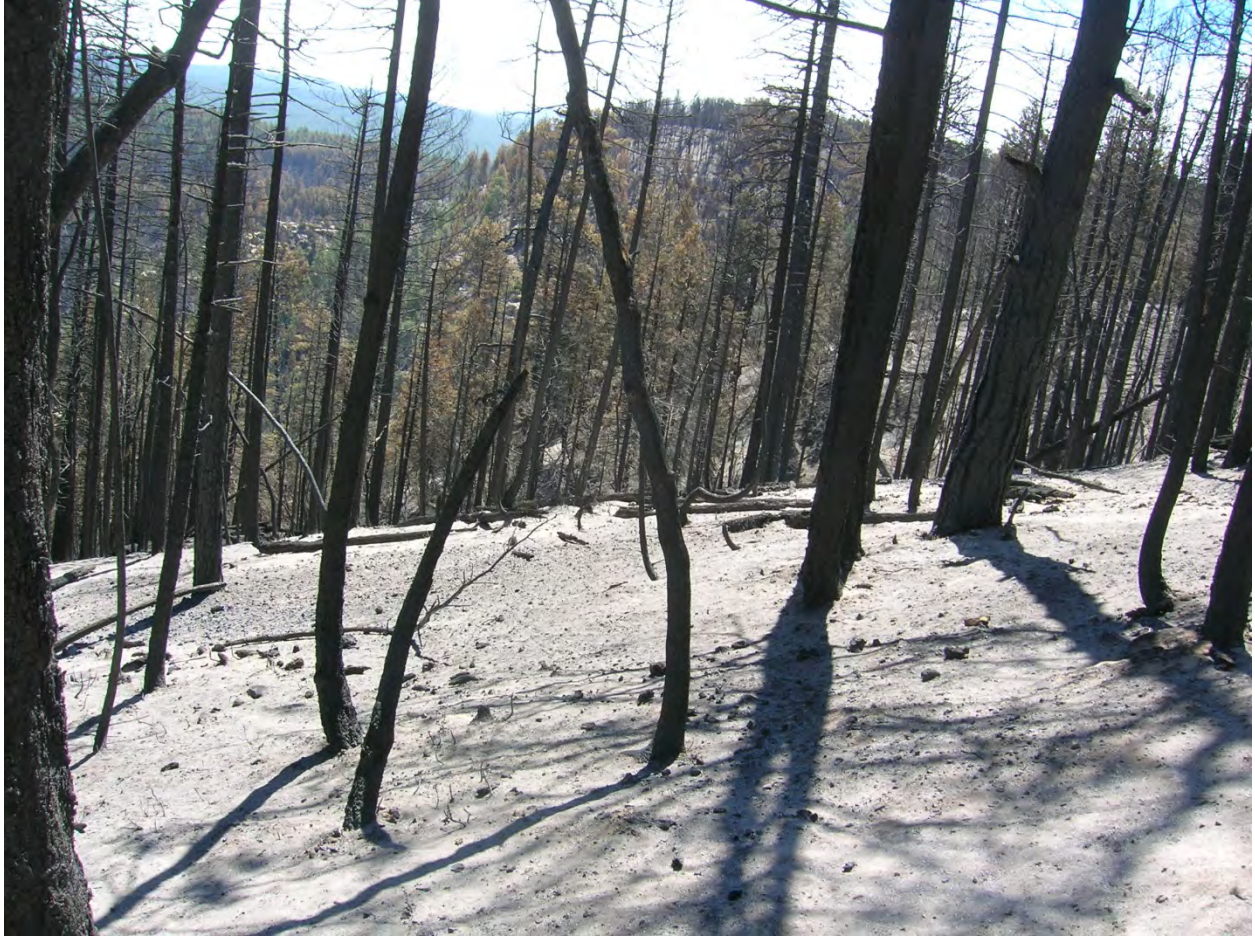
6/3/2014 – A thick layer of powdery gray or white ash covering the ground is an indicator of high soil burn severity. Ash and debris can be swept into rivers and streams by summer rain storms, potentially impacting downstream water sources.

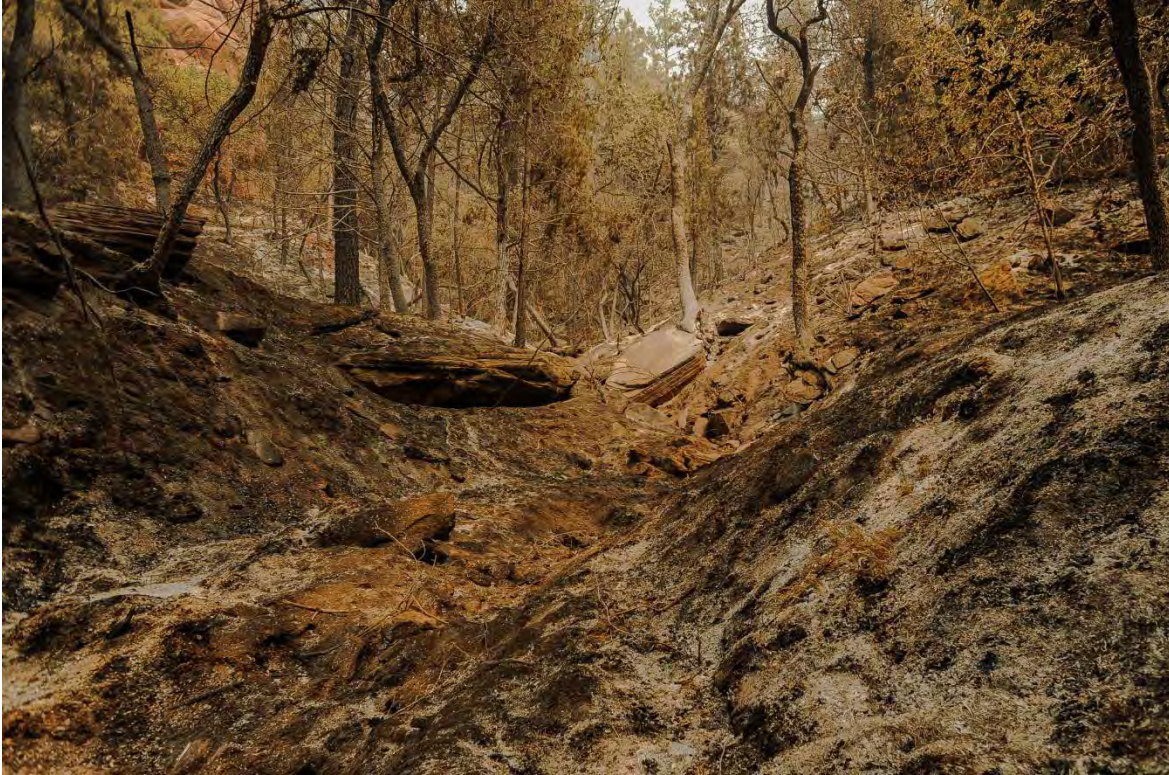
In the aftermath of the Slide Fire, a Public Information Officer with the Type 1 Incident Management Team photographed a series of photos in the West Fork of Oak Creek. This photo, north of the footbridge, illustrated the potential for ash and potential rock fall that may occur following a thunderstorm.

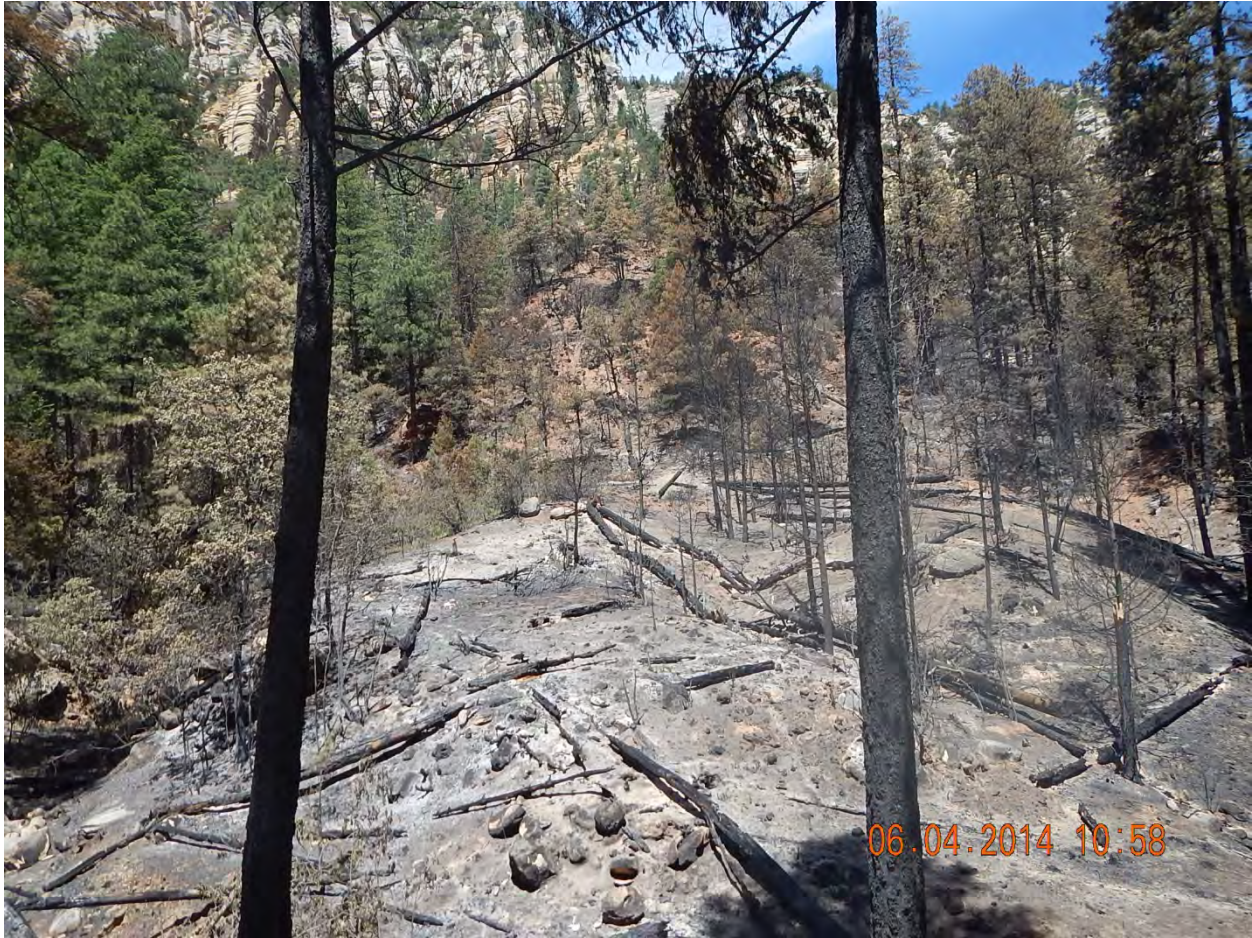
6/4/2014 – This photo, taken in Oak Creek Canyon, shows potential for debris and ash flow that may have downstream impacts following a thunderstorm.

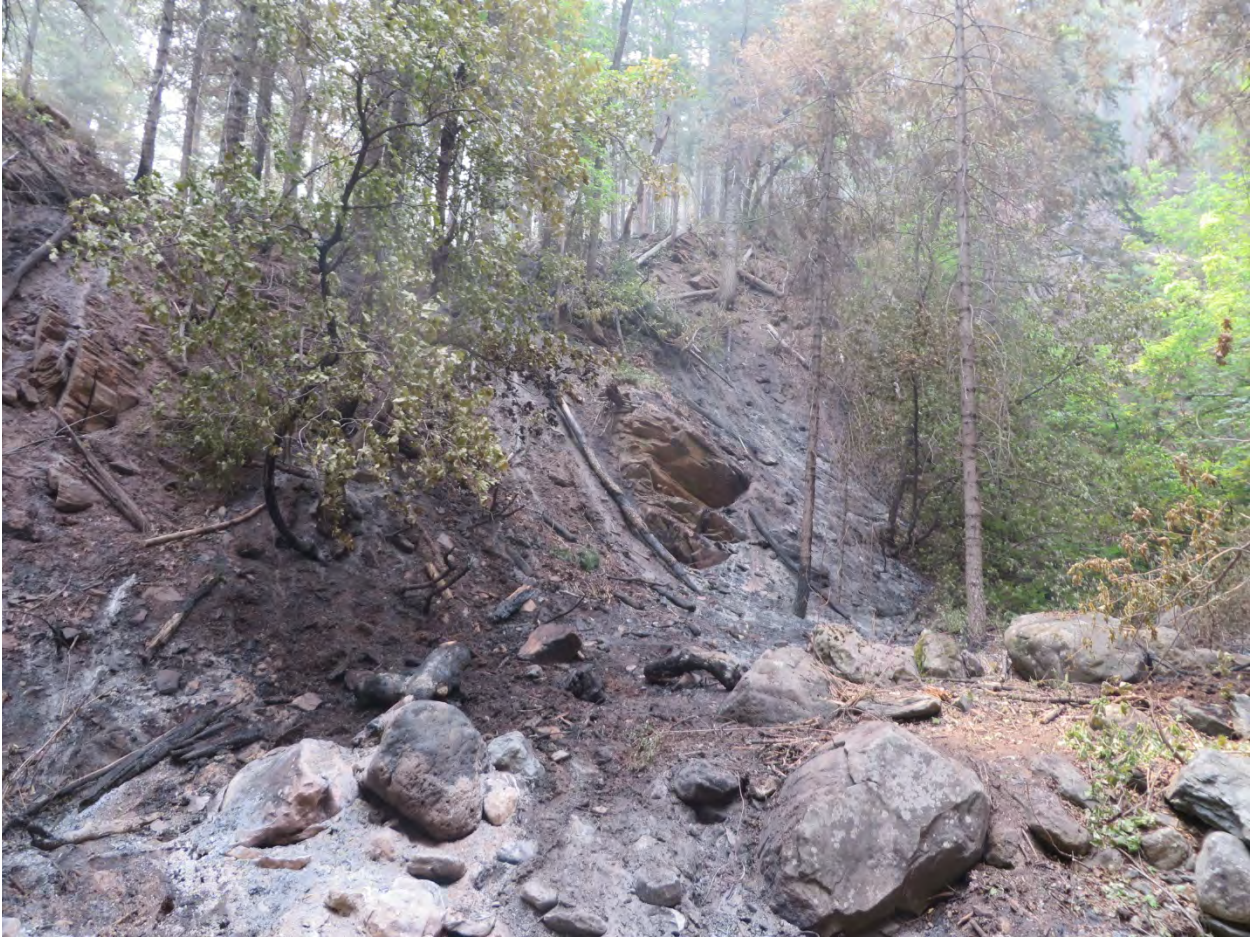
6/3/2014 – This photo, taken in Sterling Canyon, shows potential for debris and ash flow that may have downstream impacts following a thunderstorm.

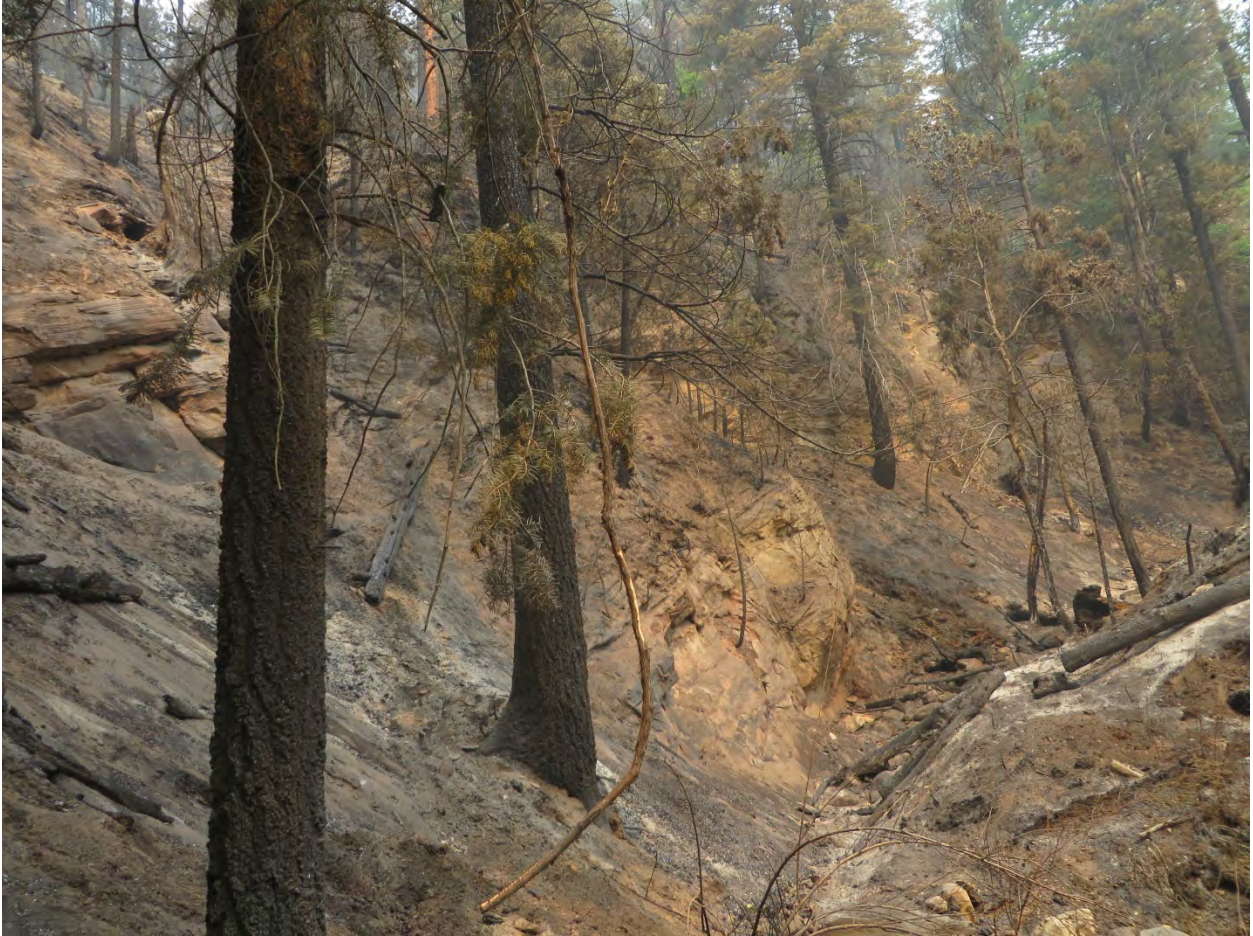
6/3/2014 – This photo, taken in Sterling Canyon, shows potential for debris and ash flow that may have downstream impacts following a thunderstorm.
